## UPPER COUPLER INSPECTION GUIDELINES

The purpose of this Recommended Practice (RP) is to provide general guidelines for the inspection of the upper coupler structure of commercial van and flatbed semi-trailers equipped with a two-inch kingpin in a fixed position coupler.

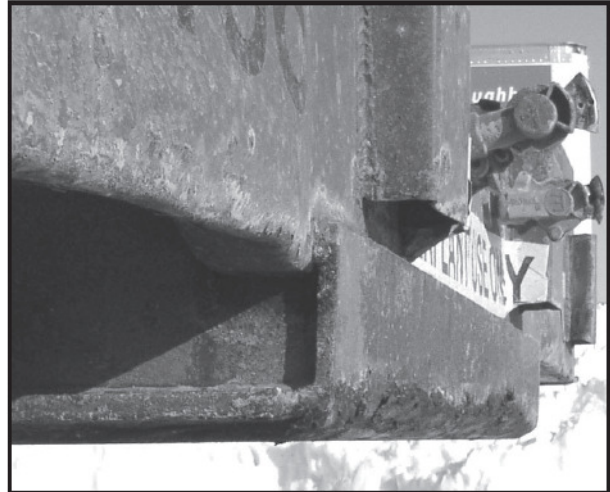
**Fig. 5**

be smooth and uniform where the lip makes contact with the fifth wheel. Sharp edges, gouges, dents, punctures, cracks, holes, excessive corrosion or any other irregularity that interferes with the smooth coupling or uncoupling of the fifth wheel should be repaired or replacements should be made. Flatbed coupler fronts are shown in **Figures 4 and 5**.

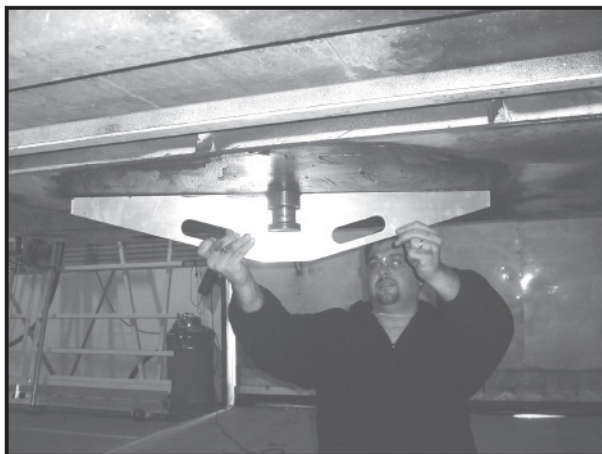
A flat bar or a template may be used to check bow in the bottom plate. The template shown in **Figures 18 and 19** quickly locates the kingpin center and allows quick measurement of bow.

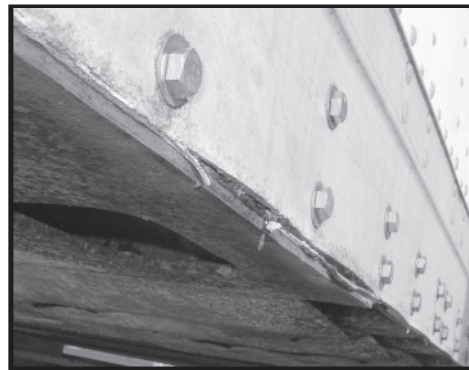
Aluminum rails that show signs of swelling (see **Figures 22 and 23**) should be checked frequently to be sure the rails do not begin to crack. Cracked rails should be properly repaired or replaced.

**Fig. 22: Swelling Between Fasteners**

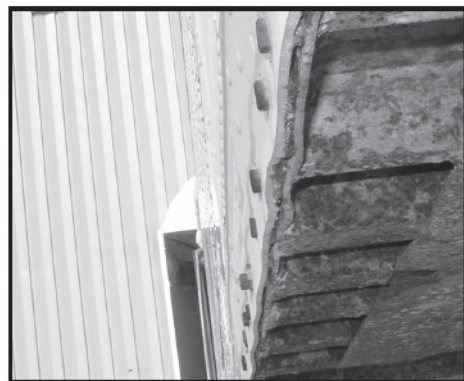
**Fig. 23: Swelling**
